## **TEST REPORT FIRES-FR-044-21-AUNE**

**Single leaf timber flush door with timber frame, type Vline Secure 30**

**Tested property:** Fire resistance  
**Test method:** EN 1634-1:2014+A1:2018  
**Test type:** Accredited  
**Date of issue:** 09. 04. 2021

**Name of the product:** Single leaf timber flush door with timber frame, type Vline Secure 30

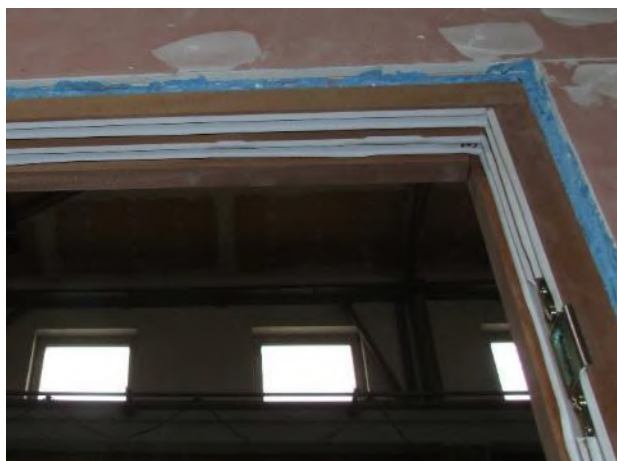
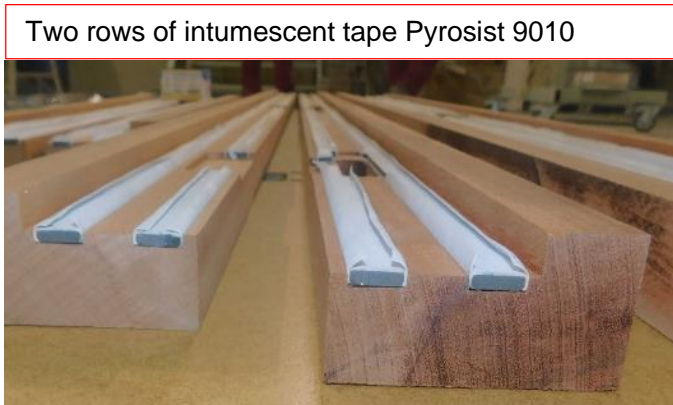
Intumescent tape, type Pyrosist 9010 (15 x 4) mm (manufacturer: RAM Extrusion Ltd) is placed in two rows around the perimeter of door frame in milled groove (15 x 4) mm.

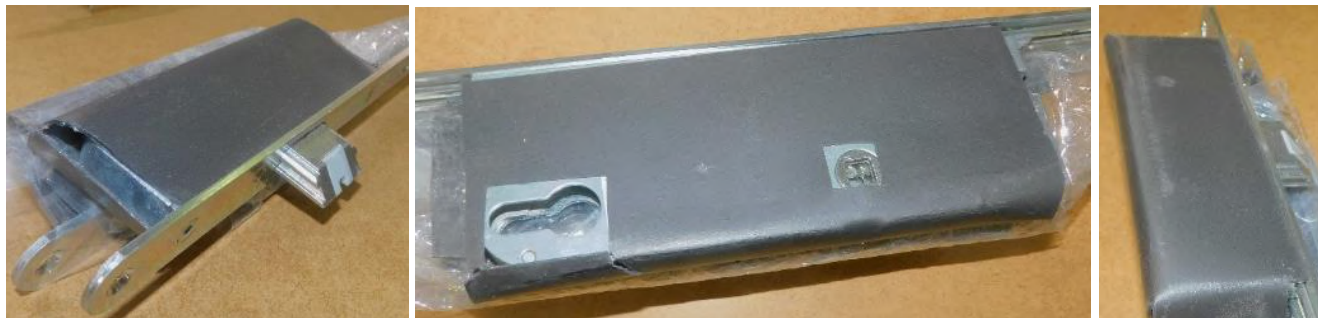
Intumescent graphite lock kit, type Pyrosist Ironmongery Protection, 1 mm thick (manufacturer: RAM Extrusion Ltd.) is placed on the mortise lock.

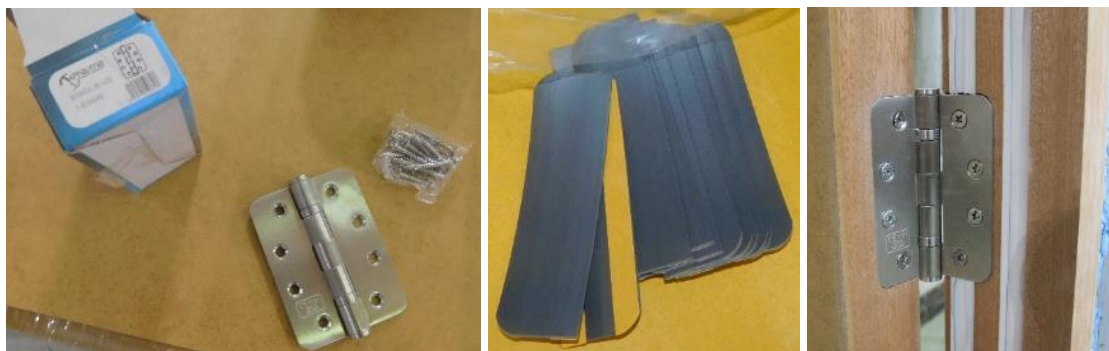
3 pieces of hinges, type BRI – 3 CE (manufacturer: Herrayma) fixed to the door leaf and door frame by means of steel screws (Ø 4 x 40) mm. Behind the hinges in joint of sapele profiles (on door frame and door leaf frame) with hinges is placed graphite pads, 1 mm thick (manufacturer: RAM Extrusion Ltd.).

Position of hinges (to the center of hinge):

- 200 mm from the bottom edge of door leaf;
- 1020 mm from the bottom edge of door leaf;
- 200 mm from the upper edge of door leaf.

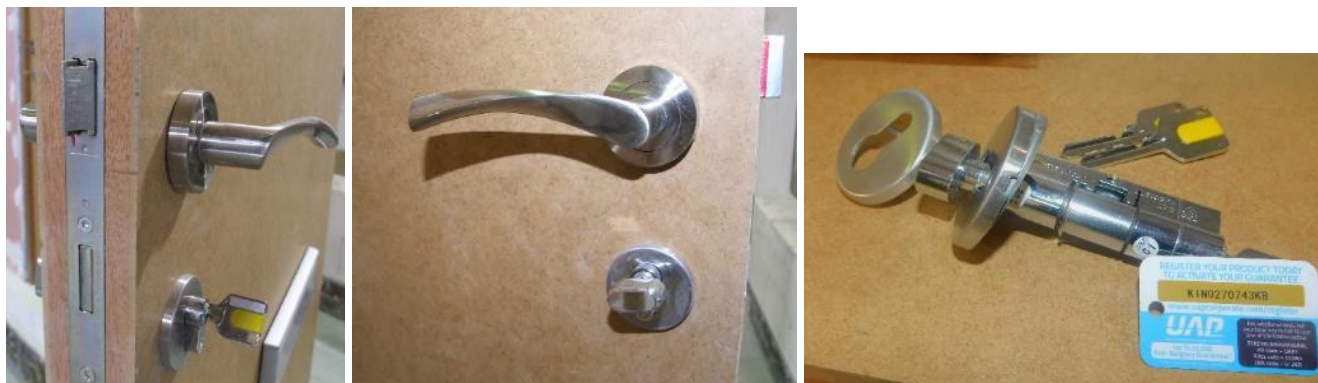
Three-point mortise lock, type G-U Secury Automatic VdS, Class A with steel strike plates (manufacturer: Gretsch-Unitas GmbH) operated by stainless steel door handles, order code: DCYVE-SN-DEV (supplier: Darcel) and cylindrical door lock insert, type KINETICA (manufacturer: UAP Limited, UK). Handle is placed 1000 mm and cylindrical insert is placed 900 mm from the bottom edge of door leaf. Lock is fixed to the door leaf by means of steel screws.

Position of latches (to the center of latch):

- bottom latch: 205 mm from the bottom edge of door leaf;
- central latch: 1025 mm from the bottom edge of door leaf;
- top latch: 235 mm from the top edge of door leaf.

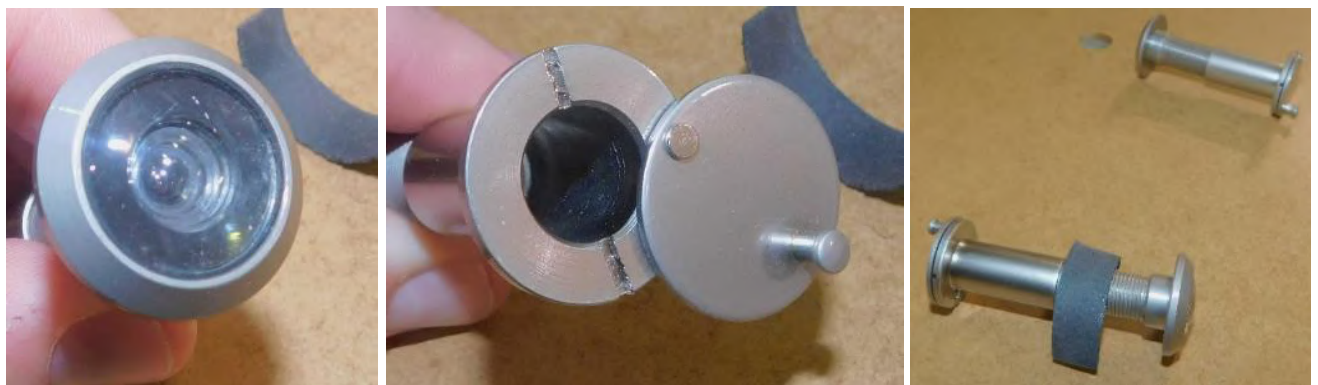
Door viewer, type EX 114, Ø 14 mm (supplier: Exitex Ltd., Ireland) is placed in the mid-width of door leaf and 1400 mm from the bottom edge of door leaf. The door viewer body is insulated (wrapped) around the viewer with strip of intumescent tape, type RAM Intumescent Paper, 1 mm thick (manufacturer: RAM Extrusion Ltd.).

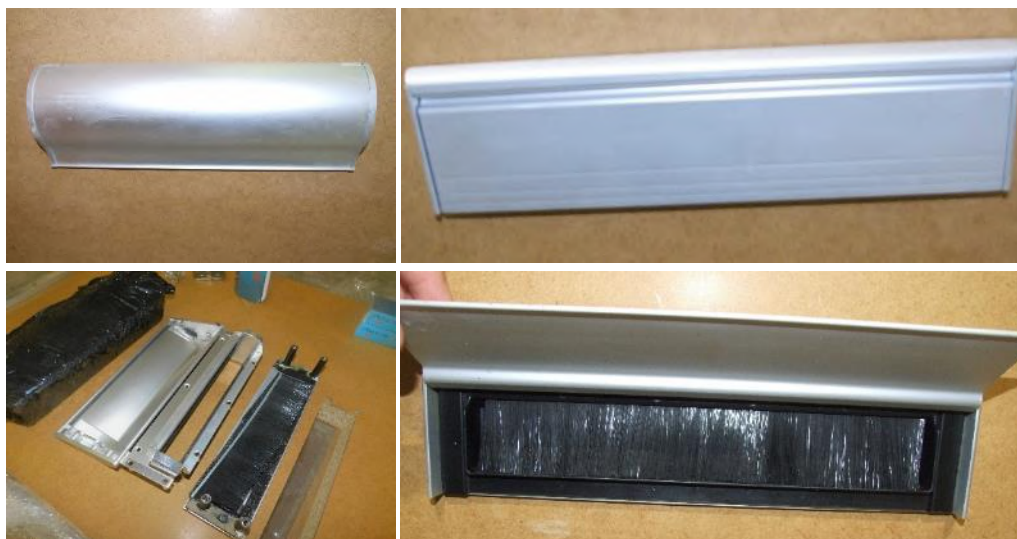
The door leaf is equipped by letter plate, type The Soterian TS008 white (supplier: UAP Limited, UK) with dimensions (305 x 75) mm fixed in formed opening (206 x 53) mm (width x height) in door leaf by means of steel screws (Ø 5 x 52) mm. The letter plate is placed 660 mm from the bottom edge of door leaf to the bottom edge of letter plate and in the mid-width of door leaf.

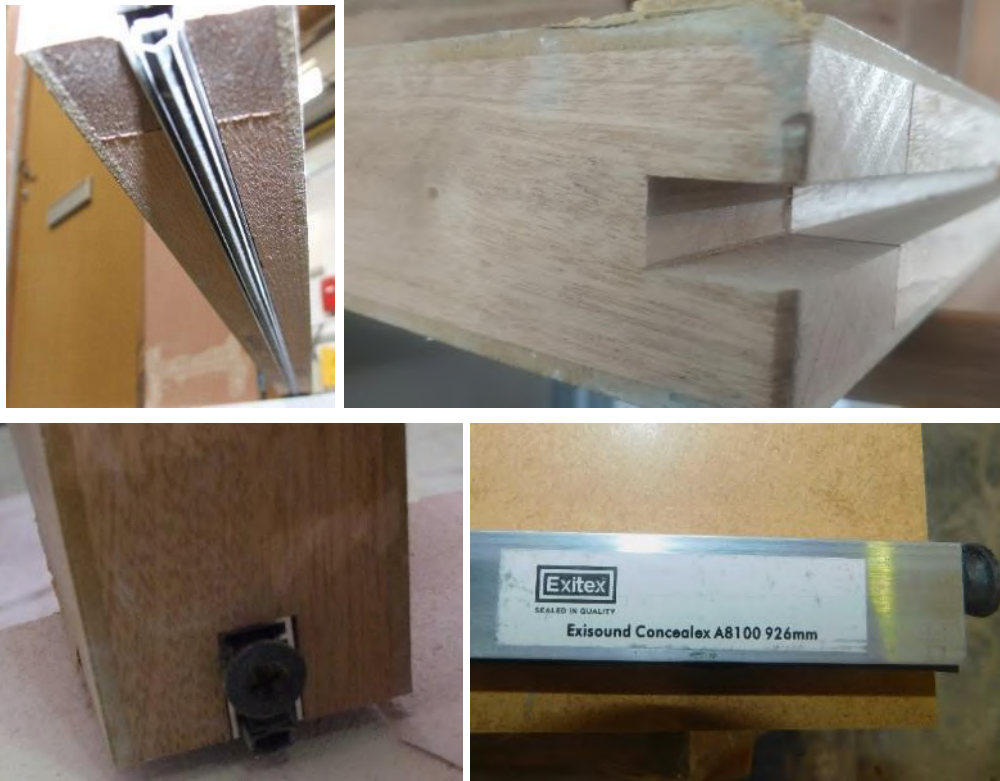
Automatic drop down seal, type Exisound Concealex A8100 (manufacturer: Exitex Ltd., Ireland) is put into the milled groove (20 x 12,5) mm and fixed by screws to the bottom edge of door leaf frame.

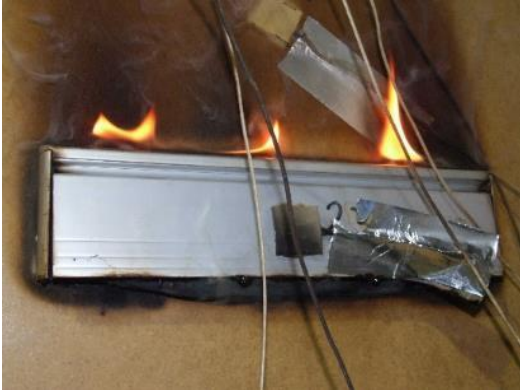
Time [min:s]	Face of specimen	Observation
43:50	NS	Sustained flaming in placed of the letter plate – <b>integrity failure</b> ;

Performance criterion	Time till the performance criterion is achieved
integrity – sustained flaming	43 minutes
integrity – gap gauges Ø 6 mm and Ø 25 mm	43 minutes no failure
integrity – cotton pad	43 minutes
insulation – average temperature (140 K)	43 minutes no failure
insulation – maximal temperature (180 K)	43 minutes no failure
insulation – maximal temperature (supplementary procedure) (180 K)	43 minutes no failure
insulation – maximal temperature (door frame) (180 K / 360 K)	43 minutes / 43 minutes no failure
radiation 15 kW.m <sup>-2</sup>	43 minutes no failure

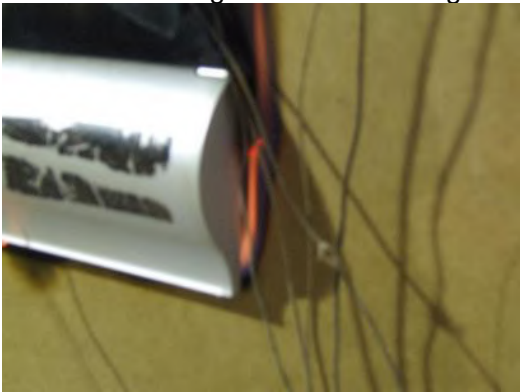
36:00	NS	No further significant changes are visible;
49:30	NS	Sustained flaming on the vertcial edge of letter plate – <b>integrity failure</b> ;

Performance criterion	Time till the performance criterion is achieved
integrity – sustained flaming	49 minutes
integrity – gap gauges Ø 6 mm and Ø 25 mm	49 minutes no failure
integrity – cotton pad	49 minutes
insulation – average temperature (140 K)	49 minutes no failure
insulation – maximal temperature (180 K)	49 minutes no failure
insulation – maximal temperature (supplementary procedure) (180 K)	49 minutes no failure
insulation – maximal temperature (door frame) (180 K / 360 K)	49 minutes / 49 minutes no failure
radiation 15 kW.m <sup>-2</sup>	49 minutes no failure

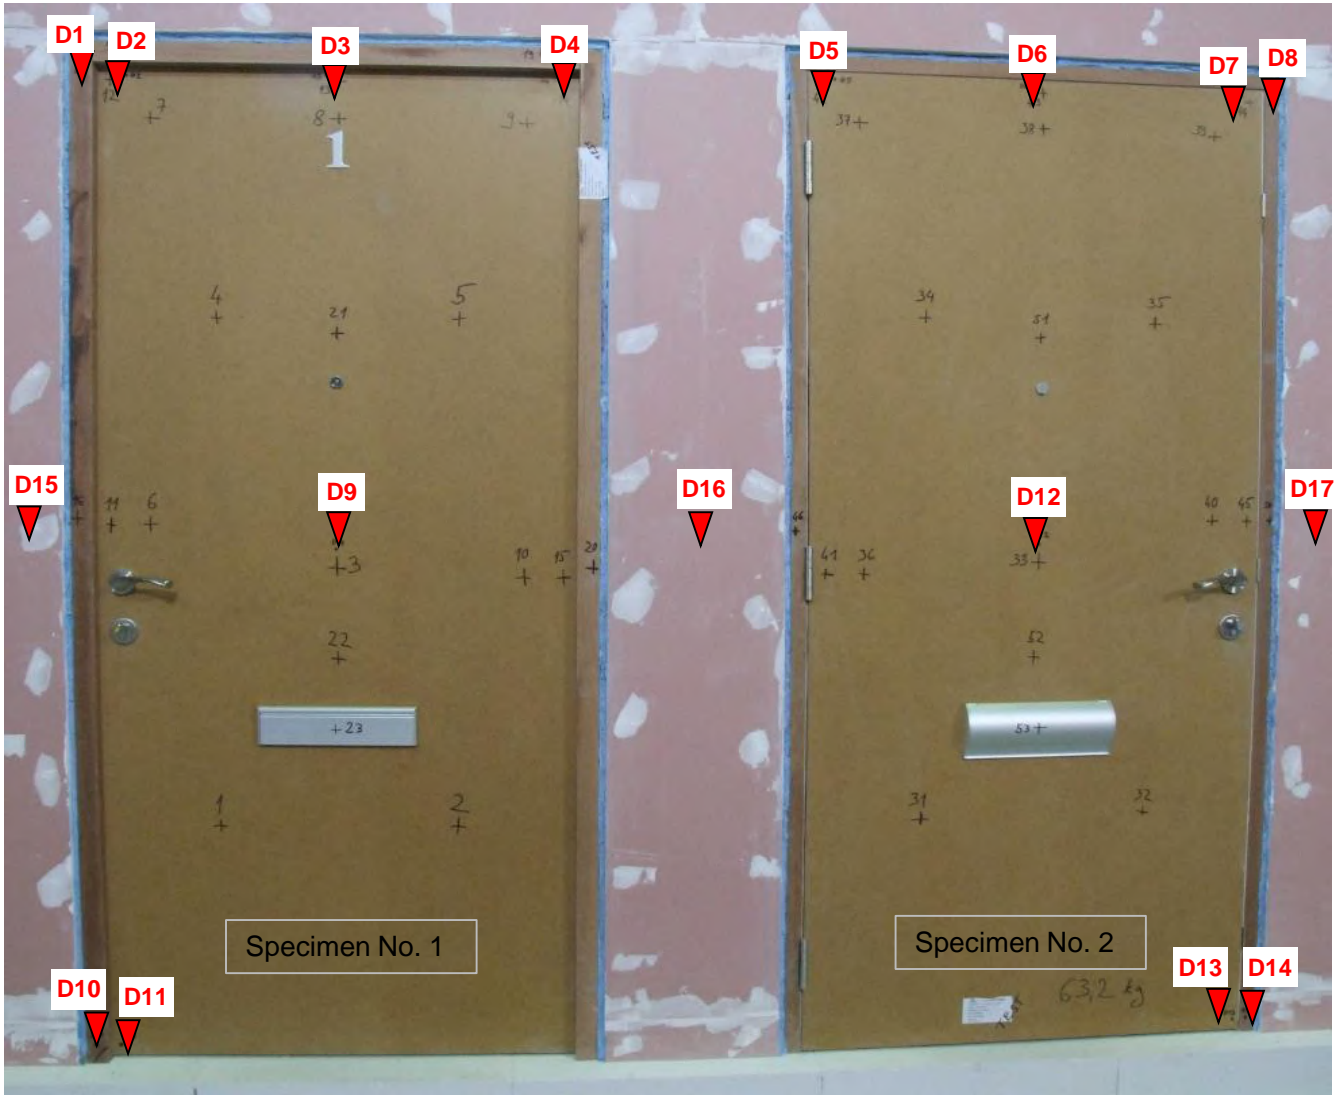
**Specimens deflection - layout of the measuring points**

- D1 to D8                      Deflection measured with cable position transducer
- D9 to D17                    Deflection measured by laser beam

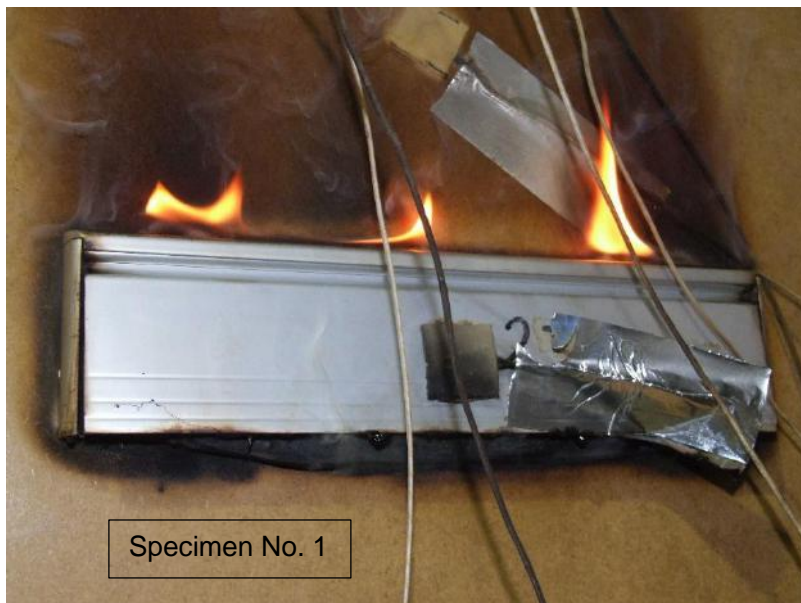
44<sup>th</sup> minute of the test

Sustained flaming in placed of the letter plate – **integrity failure**

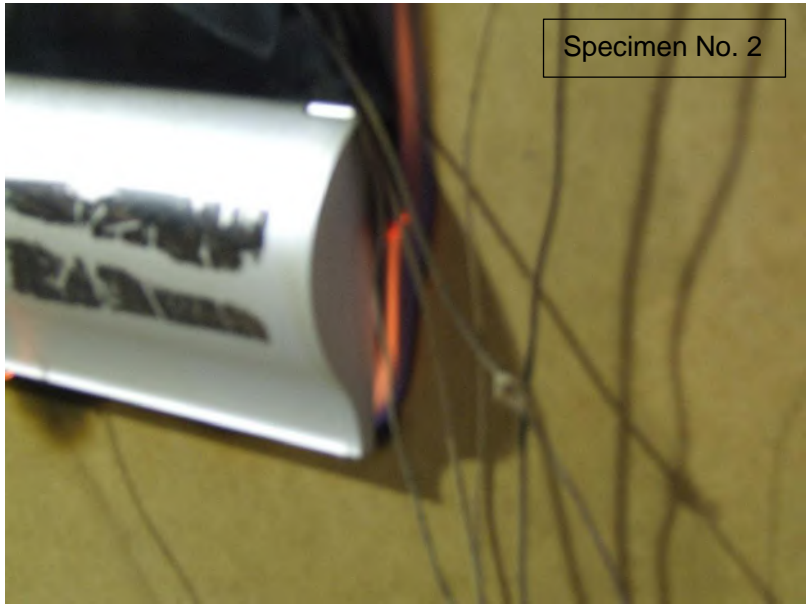
50<sup>th</sup> minute of the test  
Sustained flaming on the vertical edge of letter plate – **integrity failure**
